# Red Hill Creek - The 100+ year return frequency discharge experiment

W.K. Annable, B. Plumb, M. McKie  
Department of Civil Engineering, University of Waterloo,  
Waterloo, Ontario, Canada, N2L 3G1

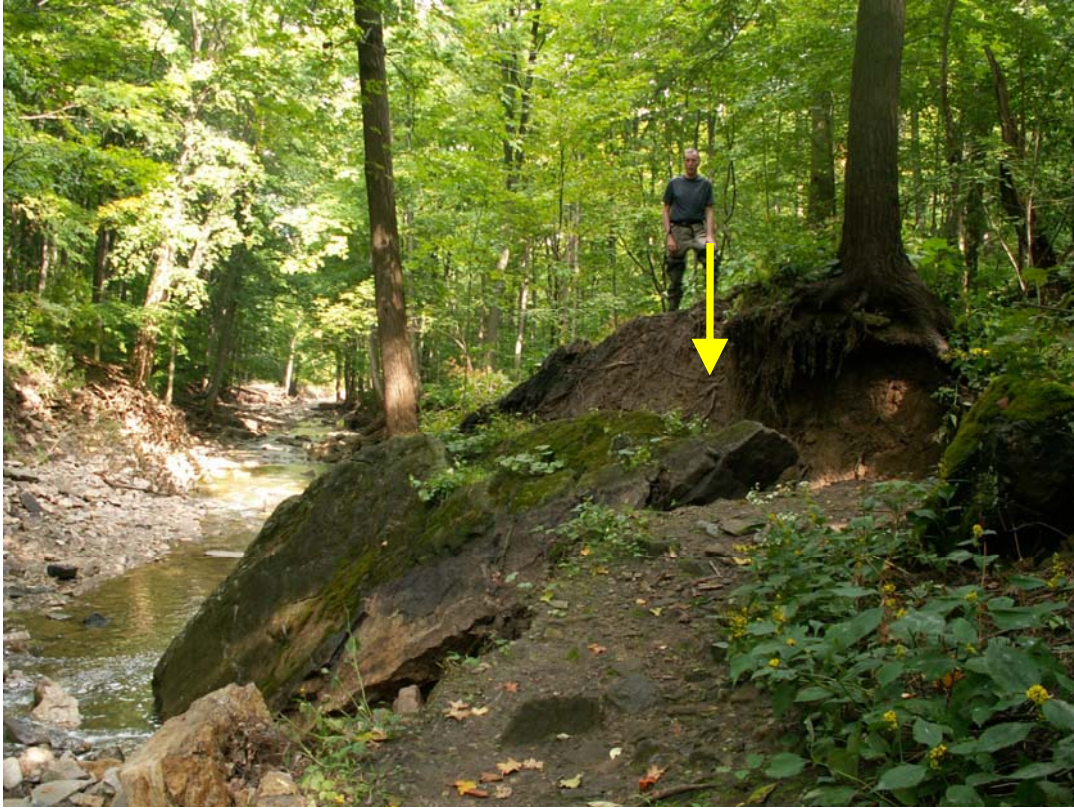
Evidence of Downcutting

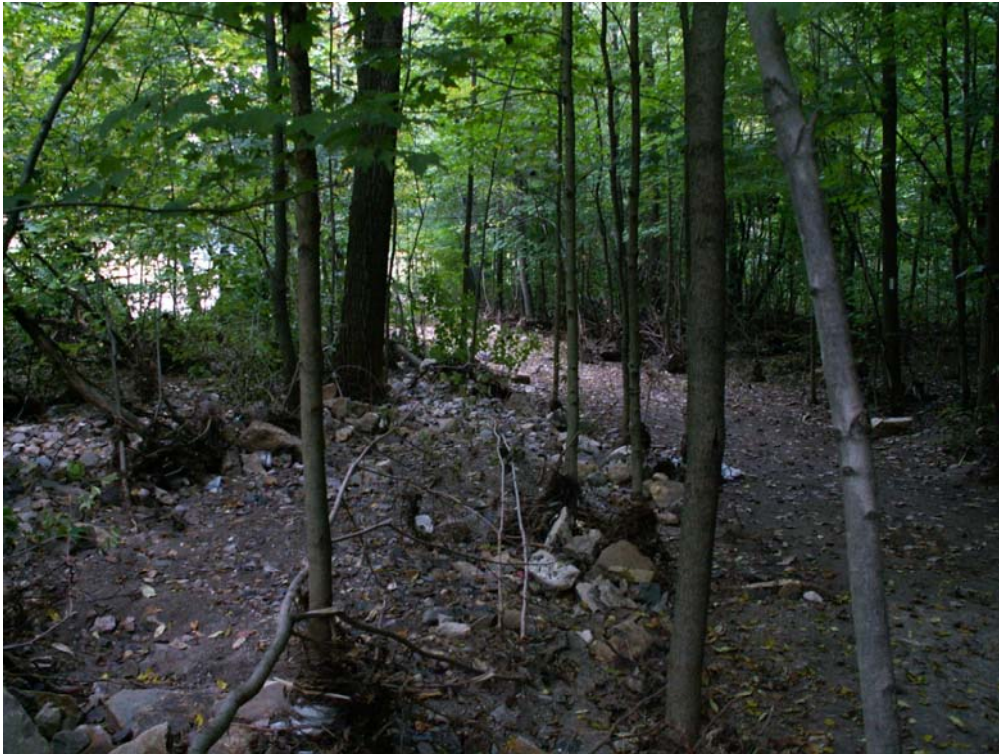
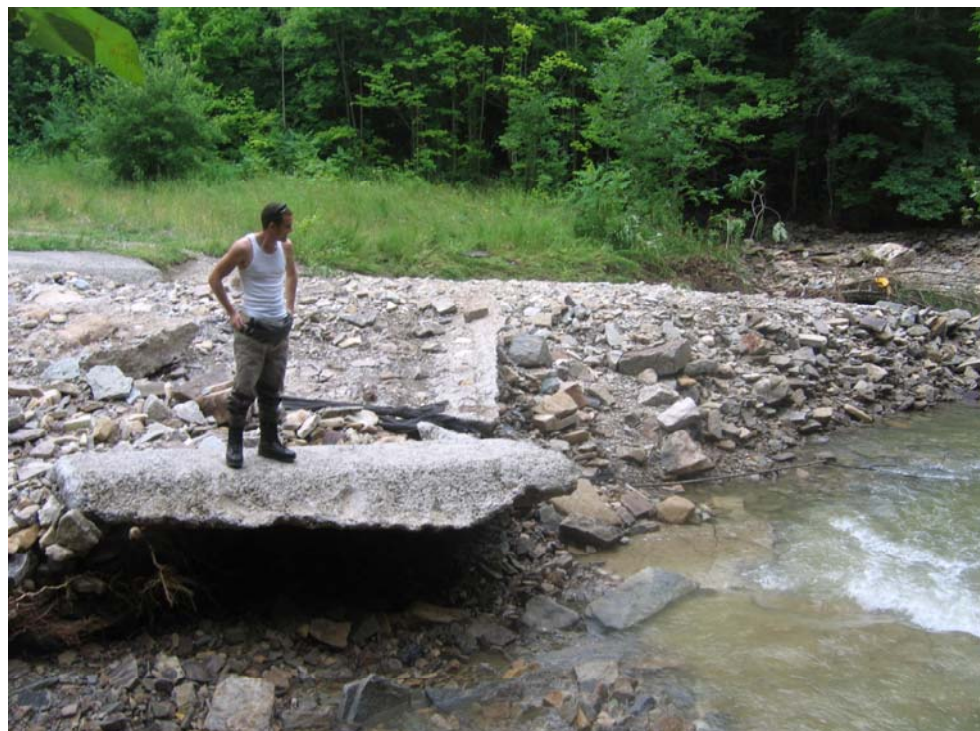
Temporary Overflow and Transport During Flood

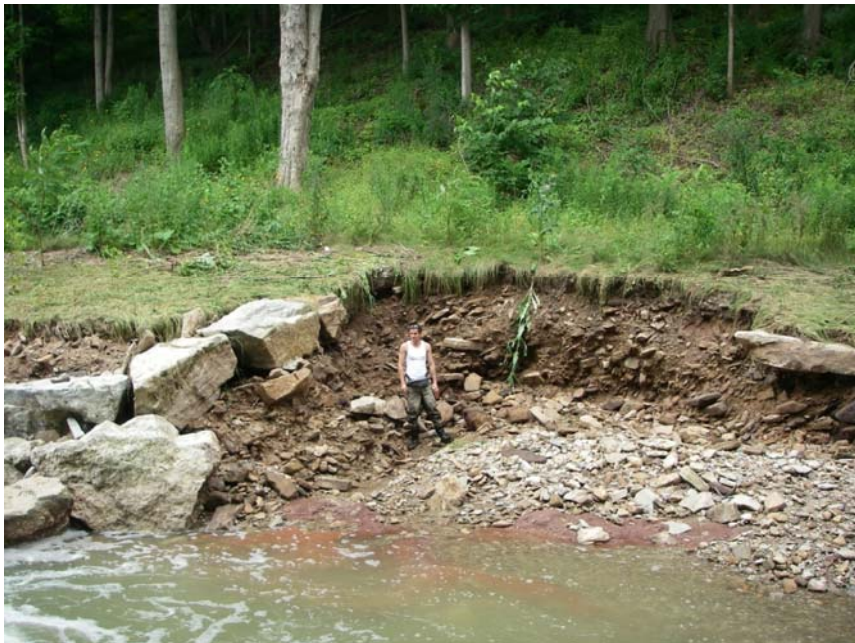
Systematic response in steeper reach sections where flow depths and velocities remained high in region between the floodplain and bankfull depth in the location of sills. Resulting in scour of very unconsolidated colluvial material. When flows undermined the sills, they continued to downcut into, and below, the main in-stream structures leading to structure failure

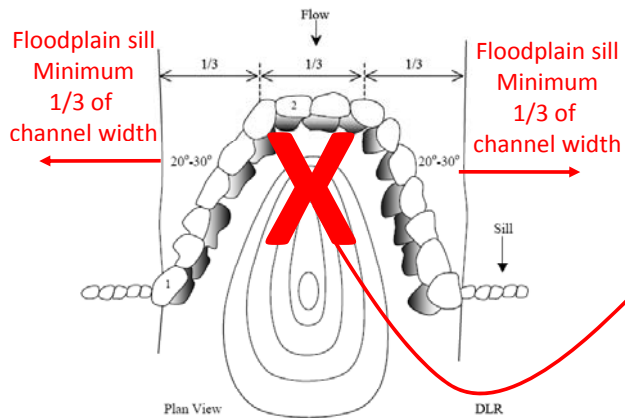
Single tier cross vanes lead to too much convergence of flow undermining footer rocks leading to structure failure in steep channel slopes and fine-grained material

Maximum arm slope found to be stable was 4% for the combined bed slope and arm slope. Therefore, if you have a 3% bed slope, the arm slope should be a maximum of 1%!

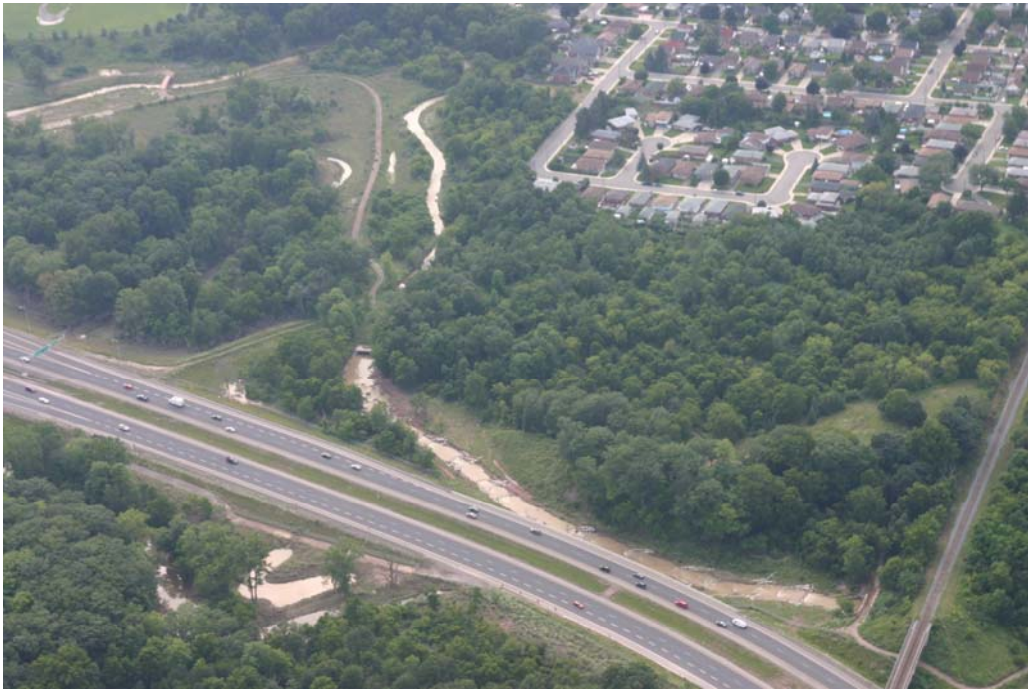
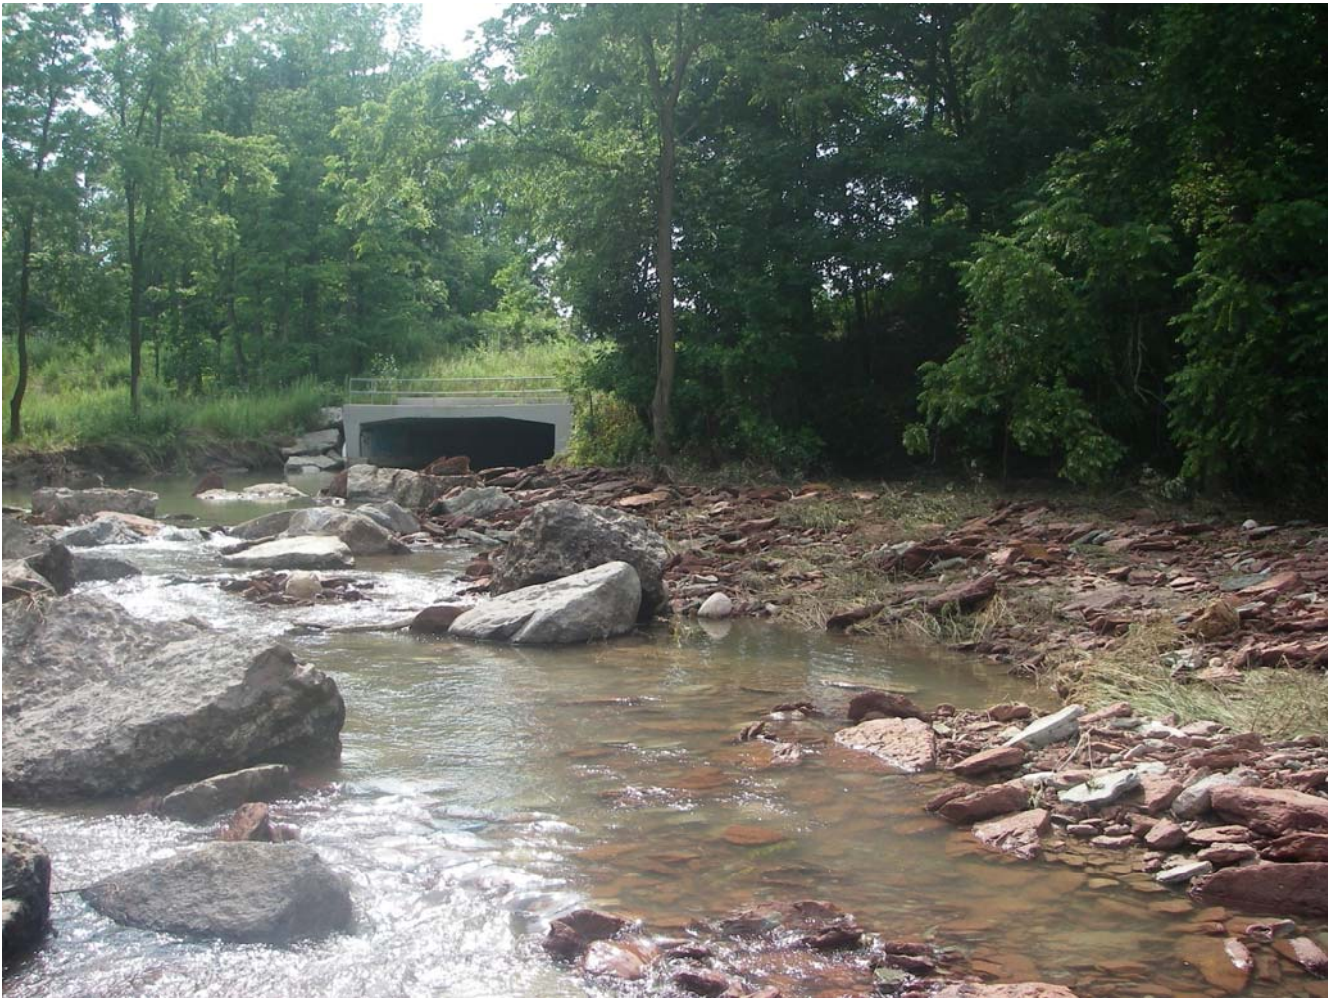
Field observations identify sizable quantities of shale in floodplain regions downstream of culvert. Concern exist over how much erosion has occurred in culvert. The culvert must be dewatered for inspection by lowering the downstream invert and reconstruction of the in-stream structures.

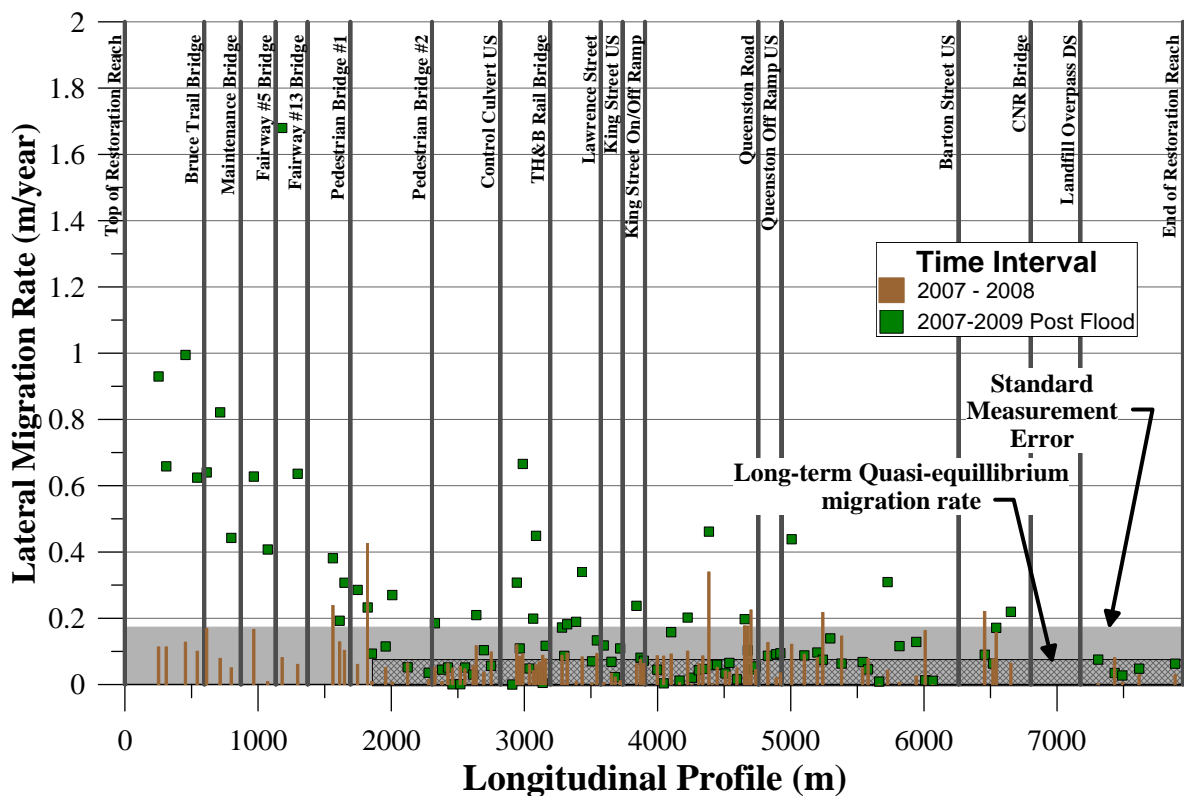
The plan profile has remained in the design location with localized minor lateral adjustments of 1m – 5m (particularly through the bend by the maintenance bridge on the golf course),

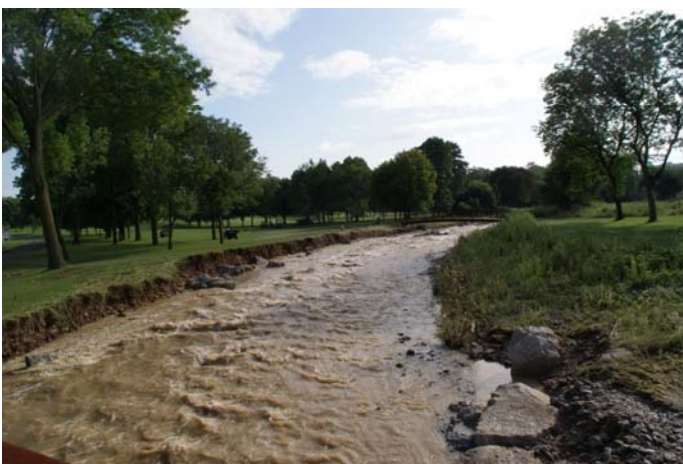
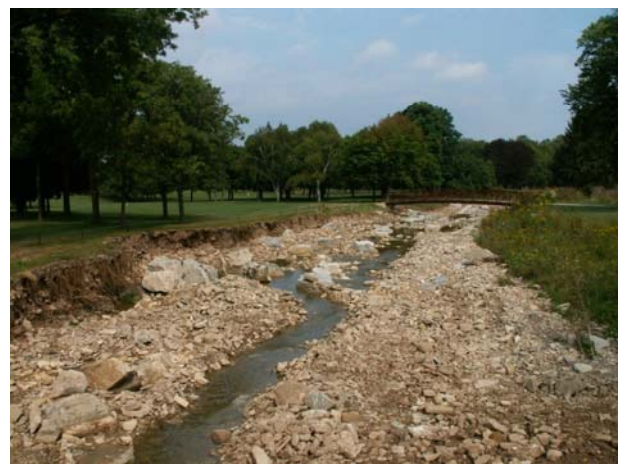
**Continued widening on concave arc of bends where structures and sills have been flanked.**

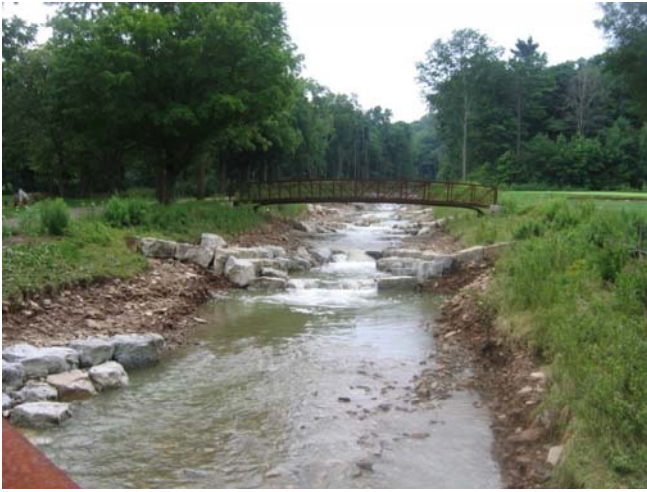
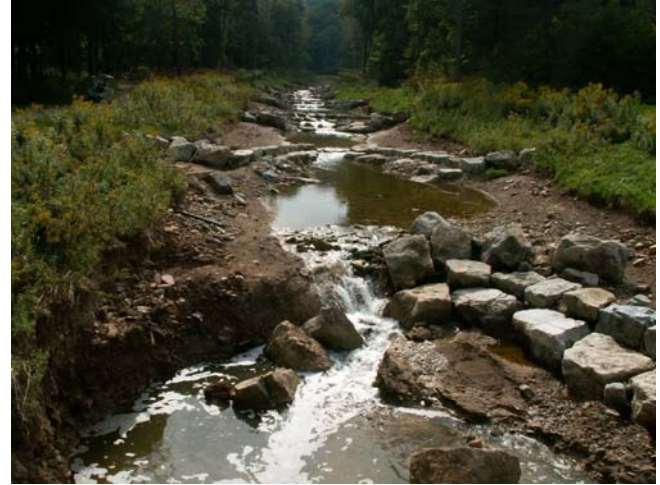
Continued channel responses demonstrate the importance of grade control to maintain vertical stability

Design of riffle structures (such as rocky ramps) need to be designed for the hydraulic radius of floods larger than bankfull the intent is for the structures to remain “stable”

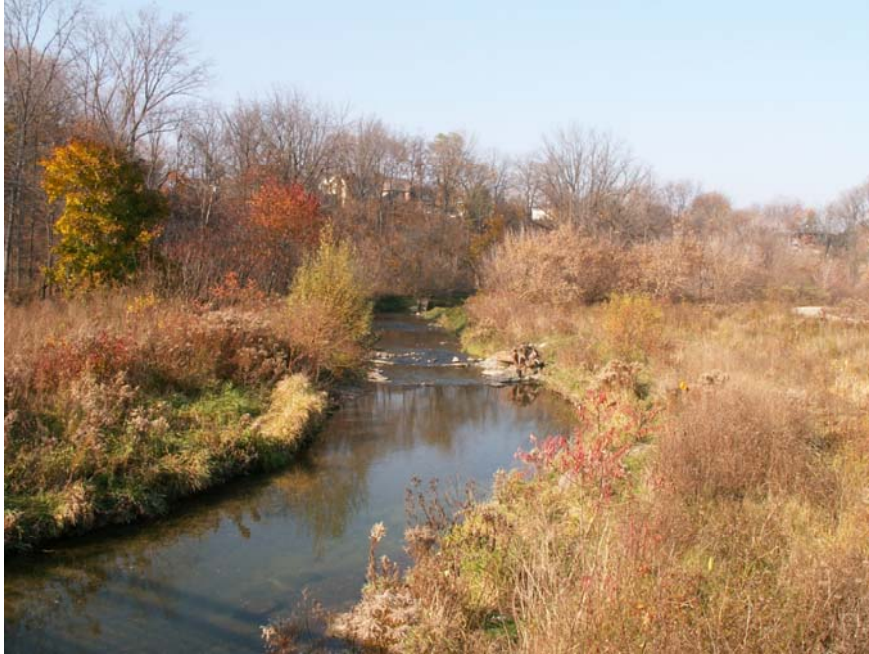
Reaches where floodplains were greater than 3 times bankfull width suffered nominal or un-measurable disturbance from the extreme flood (regardless if they were well vegetated or not).
