HP48 Repairs

by Han Duong (c) 2006

Introduction

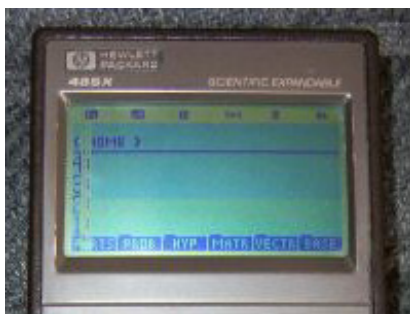
Faulty LCD

As an example, below is a photo of an HP48SX with a faulty screen. This unit has serial number 3039A02014. A few columns of pixels do not light up properly, and all the annunciators appear to be one. Upon further inspection, it turns out that when any of the annunciators are supposed to be on, then all annunciators appear to darken. When no annunciator should be on, all appear to be less dark, but still on. The screen also appears to have a darker upper half; however this is due to the slow refresh rate relative to the speed of the camera. This is a normal effect, similar to that of computer monitors when shown on T.V.

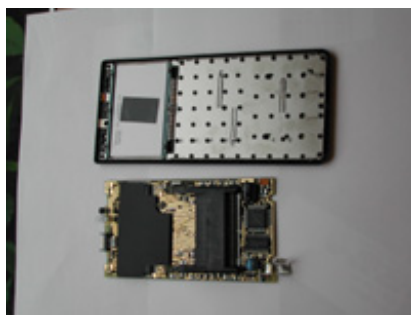
HP48SX (1)

The photos below show an HP48G and an HP48SX (serial number 3039A02014) opened and the PCB removed from the keyboard half. There are six twist-tabs which hold the PCB in place. Three are just above the LCD screen; three are just below the screen.

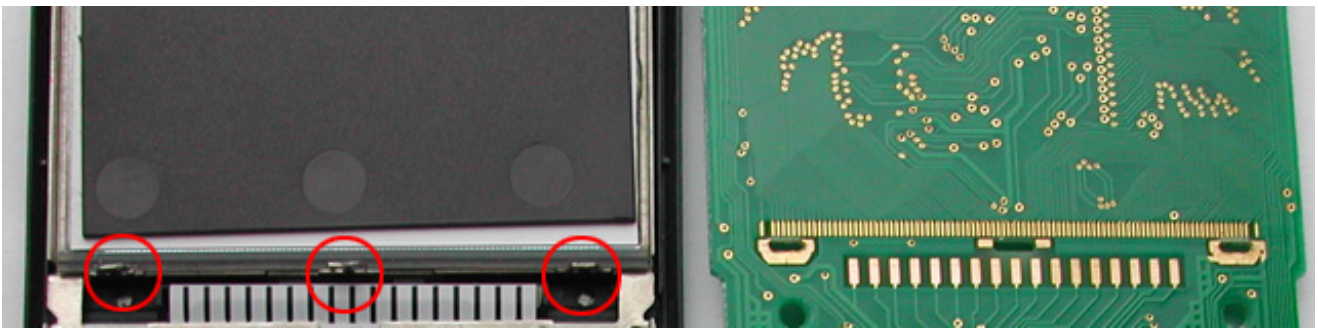
Six Twist Tabs

To remove the PCB from the keyboard layer, you will need a pair of needlenose pliers. If possible, use a pair with no teeth so that you do not warp the tabs. The tabs resemble a "T" and are not all twisted in the same direction. The top three are twisted in the same direction. The bottom three should be twisted in the opposite direction. Simply use the pliers to return the tabs to the untwisted position. While doing so, you may want to also move the pliers closer to the PCB so as to simultaneously straighten the tips. **Be careful!** The HP48S/SX PCBs are NOT silkscreened. So if your pliers happen to scrape against a trace on the PCB, you could disconnect some circuitry! The HP48G/G+/GX calculators have a silkscreened PCB. However you should still use care when undoing the tabs. Once all six tabs are lined up so that the PCB can come right off, press down on the tabs while pulling up on the PCB near the tab to slowly remove the PCB. Again, be careful that you do not scrape the traces when working with the HP48S/SX PCB! After removing the PCB, use the pliers to straighten out the tabs so that when you put the PCB back later on, they will not scrape the insertion points and cause PCB dust to fall onto the LCD or keyboard connectors.

WARNING: You should keep to a minimum the number of times you twist and untwist the six tabs that hold the PCB to the keyboard layer as these will eventually break. Once even a single tab breaks, you will NOT be able to fix it. And the pixel/keyboard problems could possibly be worse than before. So make sure you know what you are doing.

And now onto the PCB itself. First, we need to place the PCB back into position. However, do NOT just plop the PCB over the six tabs. The tabs, even when straightened, could possibly scrape the inside of the insertion holes. The resulting PCB dust could then fall back onto the LCD strips and leave rows/columns of missing pixels. So the idea is to essentially hold the PCB just above the six tabs, then hold the entire keyboard and PCB assembly above your head (so that the PCB is closest to the ground and the LCD screen is facing the sky) and *then* press the PCB onto the keyboard layer. Any dust from the tabs scraping the PCB's insertion holes should fall to the ground. Then put everything back on a flat surface and twist the six tabs back to their original positions. The key here is to hold your needlenose pliers as close to the PCB as possible. Press the PCB down while twisting the tabs so that you do not have air gaps in between the LCD and/or keyboard connectors.

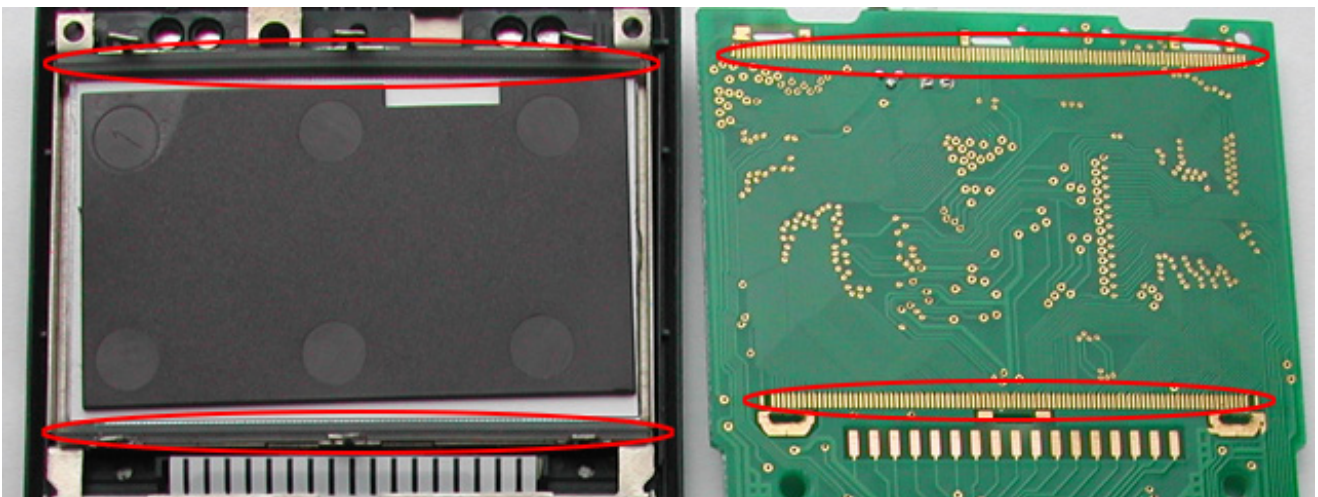
HP48G LCD Connectors

Notice in the picture below how the LCD connectors (circled in red) near the top are very close to the IR and serial ports. It is not too hard to imagine how dust can get in via the serial port opening and lodge in between the rubber-like material that attaches to the LCD and the connector pads on the PCB.

If the LCD does not need replacing, the only thing you should have to do is to make sure the contact points are clean. Again, a lint-free cloth and alcohol should do. I personally use a product called "klear screen" (for the purpose of cleaning laptop LCDs). It is highly unlikely that you should have to remove the two LCD strips and clean underneath them. However, if all else fails, this may just be the solution. The last step is to make sure that the PCB is tightly put back into place (more on that below).

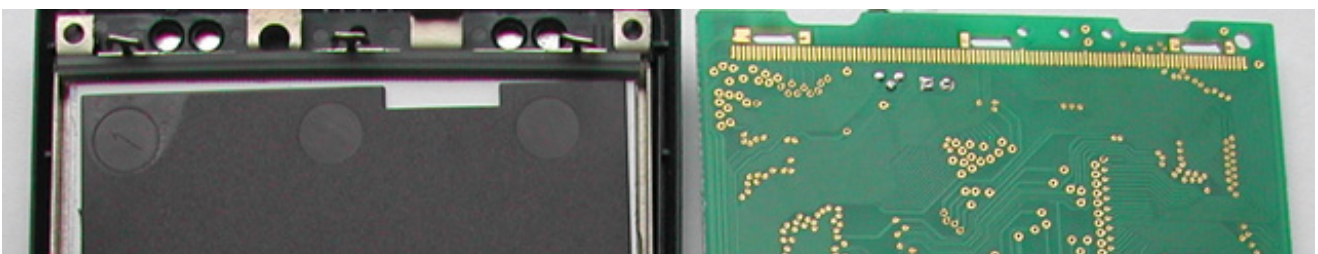
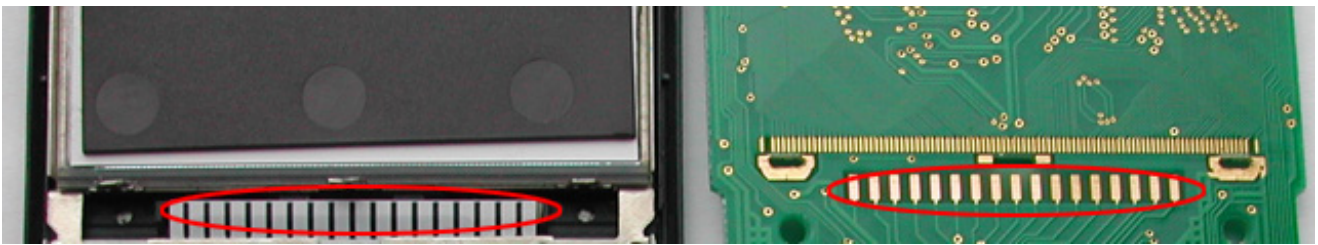
HP48G Keyboard Connectors

In the photo above, the keyboard connectors are circled in red. On the left you can see the contact points. Underneath is a small piece of rubber-like material which is supposed to push the contact points against the PCB connectors. This piece (shown below) can decay over the years, or become overcompressed. The result is a gap between the PCB and the keyboard contacts. It is also possible that in the expandable modules, overuse of the card slots could lead to LCD or keyboard problems. RAM and ROM cards connect to the PCB via the card connector. When you pull the card out of the slot, you are lifting up (ever-so-slightly) on the card connector. The three tabs below the CPU eventually loosen up and then either dust or an air gap forms in between the PCB and the contacts from the keyboard layer. This is why the keyboard problems occur more often in the expandable series (at least in my experience, I have noticed far more expandable models with nonresponsive keys).

Note how there are 17 contacts for the keyboard. One is for the Vbat signal. One is specifically for the ON key. The remaining fifteen are dedicated to the row and columns (not exactly the typical definition of a column) of the keyboard. Thus, if a single contact does not function, you are likely to lose an entire row or column of keys. On the other hand, if a single key does not function properly, then it is unlikely a problem with the connectors. Instead, you may have problems within the keyboard. When you press on the bezel below the LCD, you are essentially pressing the keyboard contacts onto the PCB connectors. This is why nonresponsive rows and/or columns of keys may become active again.

There are several things you can try. If it is clear that the connectors are dirty, try cleaning them. Use a lint-free cloth and alcohol to clean the contacts. If it is clear that the rubber piece underneath the contacts has been overcompressed, or has decayed, you can try to use a business card and cut a thin strip to place underneath the contacts. This should help press the contacts against the PCB once you put the PCB back into place. Of course, a piece of rubber of equivalent thickness would work as well. You may even want to try cutting up a thick piece of rubber band and see how it goes. The last step is to make sure that the PCB is tightly put back into place (more on that below).

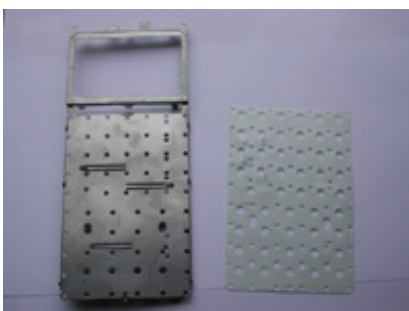
HP48 Keyboard Anatomy

If the nonresponsive keys cannot be fixed by cleaning the contact points or tightening the PCB to the keyboard layer, then it is unlikely the keys can be fixed at all (unless the entire keyboard layer is replaced). The keys are all attached to a layer of plastic, on top of which the metal overlay is placed. On the opposite side is a metal plate, to which the PCB is attached. And sandwiched in between the plastic layer and the metal plate is the circuitry for each key. The metal plate is then heat-staked onto the plastic layer via a large collection of rivets. So in order to get to a single key, one would essentially have to destroy the rivets holding everything together. Below are photos of the various layers within the keyboard. This setup is essentially the same for the entire HP48 family. There may have been a few modifications over time, but the general design remains the same. In fact, the keyboards are interchangeable; you can use an HP48S/SX keyboard with an HP48G/G+/GX motherboard!

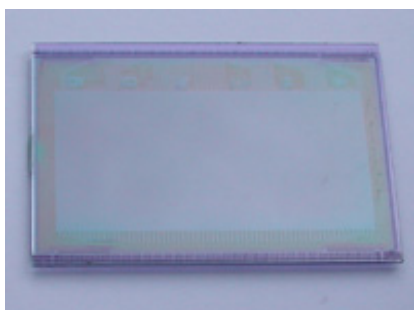
LCD: Front

The LCD is less complicated and consists of the screen and two rubber-like pieces which are responsible for forming the circuit between the screen itself and the PCB. The LCD screen is attached to the keyboard layer via two (practically speaking) pieces of thin, double-sided, clear tape. One strip lies at the top, another at the bottom. The thickness of this tape is significant. If it is too thick, then you might create a gap at the keyboard connectors.

If you need to replace the LCD screen, you will need a replacement screen along with the two LCD strips (again, it may be the case that these strips are NOT interchangeable). Make sure that you are working in a dust-free environment! First, clean the connector strips on the LCD screen as well as the two rubber strips. Then clean the surface within the LCD housing area and replace the double-sided tape if necessary. Place the LCD screen face down. If examine the sides of the LCD screen, one side should have a slight bump to indicate the correction orientation of the screen. If you are looking at the back of the screen, the bump should be to the right side. Alternatively, you can hold up the screen at an angle and see where the annunciators are supposed to be and use that to correctly orient the screen. Once the LCD screen is in place, place in the two rubber strips and make sure that they are in the correct orientation (see further above). I am not sure if this makes a difference, but it is better to be safe than sorry. I personally have always placed them the way they appear prior to removal.

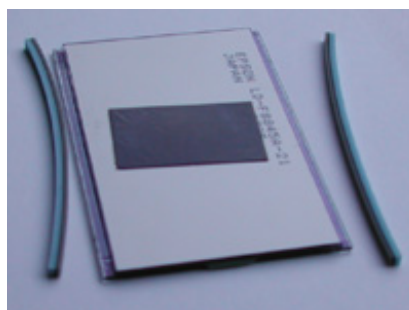
LCD: Back & Connectors

To remove the LCD screen, first hold the keyboard layer so that front of the LCD is facing down. **Take note of the orientation of the strips. Some have two different colors whereas others are more difficult to discern how they are oriented.** Nevertheless, a magnifying glass will reveal the spots where the three metal tabs come into contact with these strips. Use this to help you correctly orient the strips during a repair. Use both hands and place your thumbs up
