# Red Hill Creek - The 100+ year return frequency discharge experiment

W.K. Annable, B. Plumb, M. McKie  
Department of Civil Engineering, University of Waterloo,  
Waterloo, Ontario, Canada, N2L 3G1

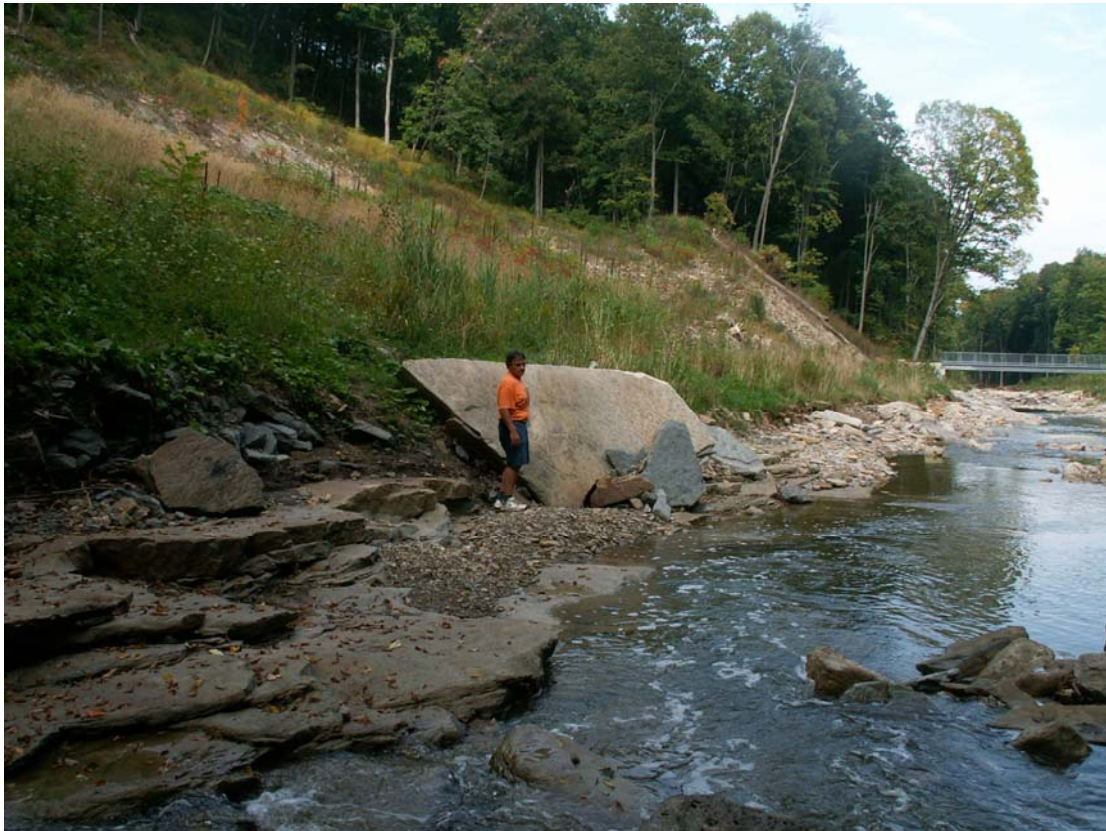
# Upstream

Temporary Overflow and Transport During Flood

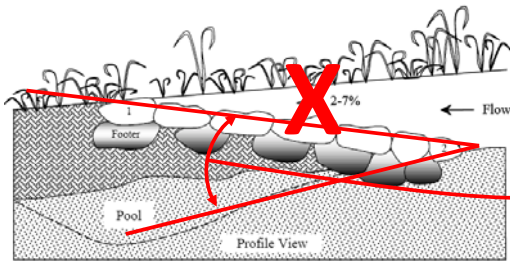
# In-stream Structure Observations

Maximum arm slope found to be stable was 4% for the combined bed slope and arm slope. Therefore, if you have a 3% bed slope, the arm slope should be a maximum of 1%!

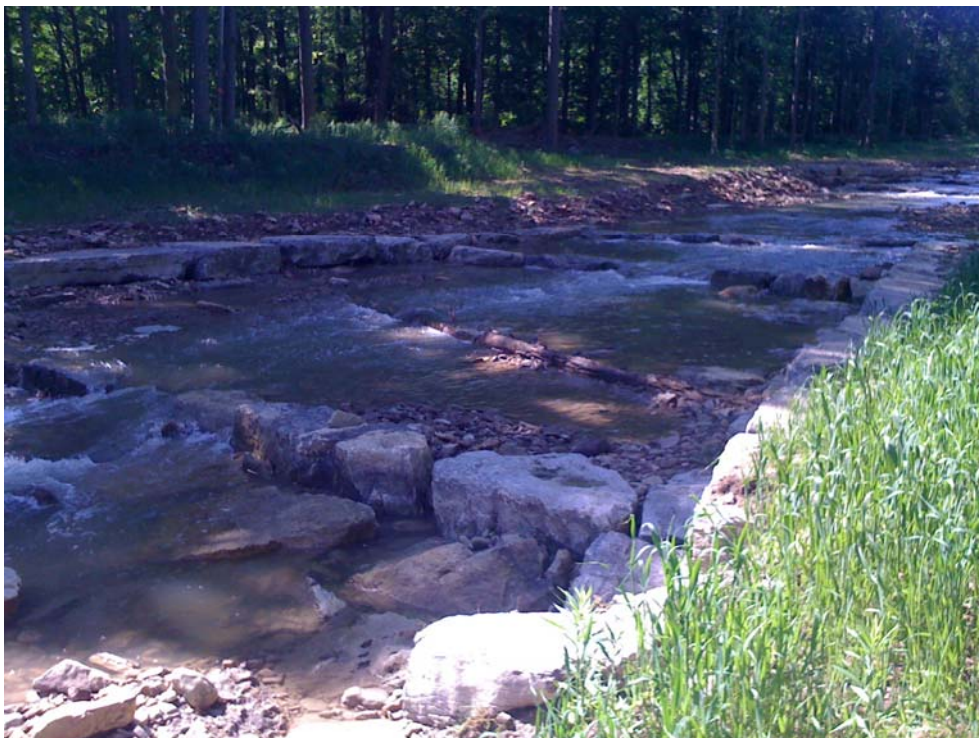
# Cascade Vanes

Single tier cross vanes lead to too much convergence of flow undermining footer rocks leading to structure failure in steep channel slopes and fine-grained material

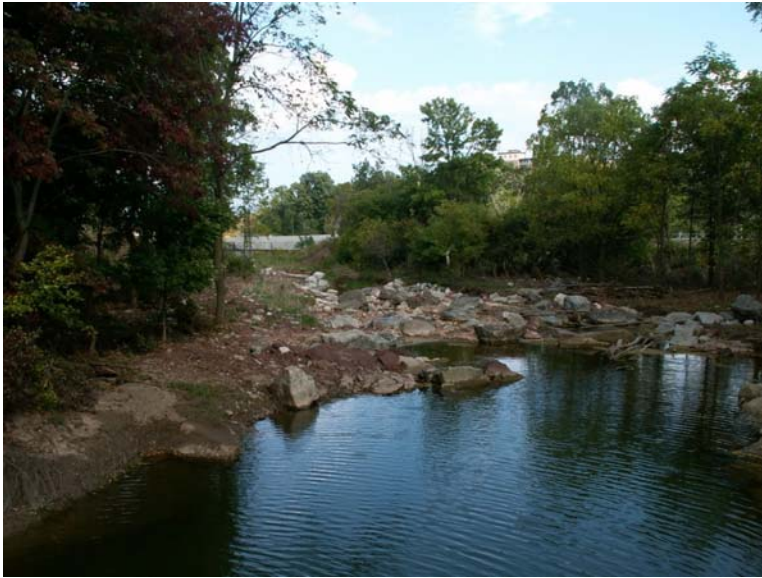
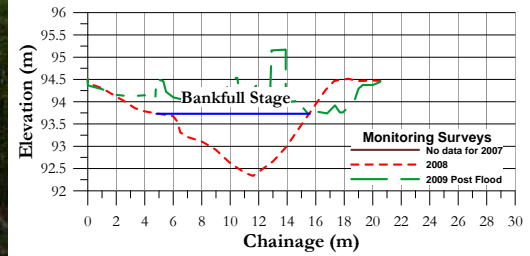
Known long-term maintenance location

Field observations identify sizable quantities of shale in floodplain regions downstream of culvert. Concern exist over how much erosion has occurred in culvert. The culvert must be dewatered for inspection by lowering the downstream invert and reconstruction of the in-stream structures.

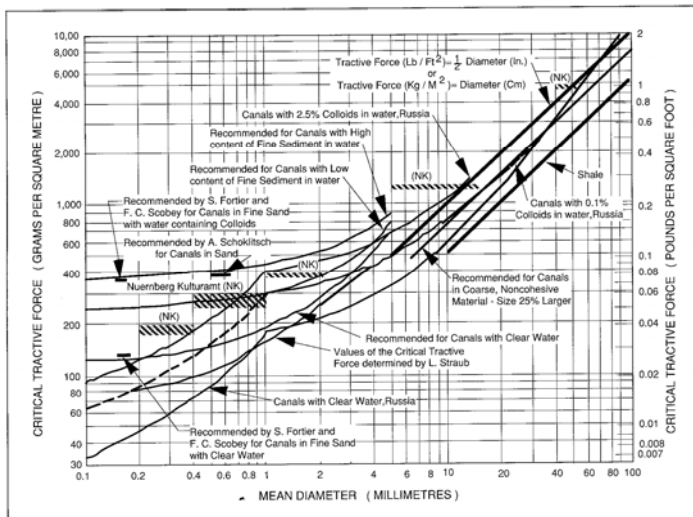
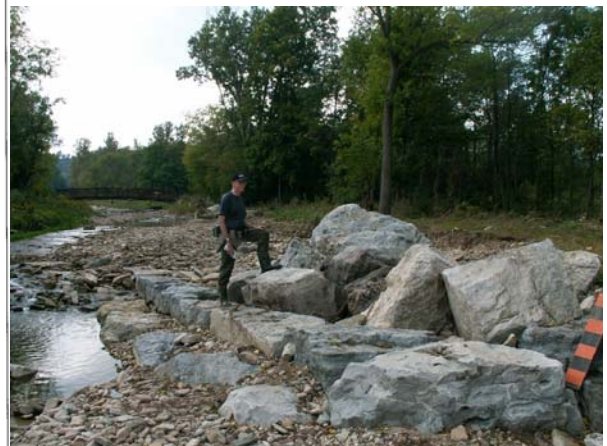
Continued channel responses demonstrate the importance of grade control to maintain vertical stability

Design of riffle structures (such as rocky ramps) need to be designed for the hydraulic radius of floods larger than bankfull the intent is for the structures to remain “stable”
